The study on the rough surface of KFC copper strip applied to lead frame*

HUANG Guo-jie(黄国杰), XIE Shui-sheng(谢水生), CHENG Zhen-kang(程镇康)

(State Key Laboratory for Fabrication and Process of Non-ferrous Metals,
Beijing General Research Institute for Non-ferrous Metals, Beijing 100088, China)

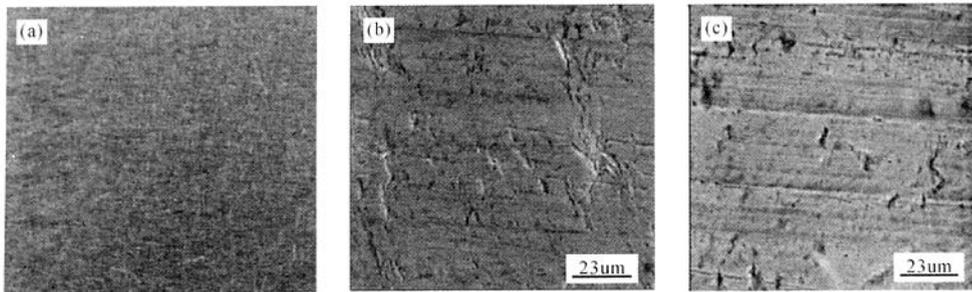
Fig. 1 Surface topography of the products

(a)—macroscopic pattern of the deficient product; (b)—the surface of the deficient one; (c)—the surface of the acceptable one

The defect of rough surface exists at both sides of the strips and stretch along rolling direction. The macroscopic pattern of the defect product is shown in Fig. 1 (a). It appears like fog and distributes uniformly on the surface and has no luster. You will feel it smooth and just like the acceptable sample when you touch with your fingers.

The surface topography of the defect product in the SEM is shown in Fig. 1 (b) and the acceptable one is shown in Fig. 1(c). We find that there are lots of thick and regular pitting of the defect product in the microstructure. The pitting surface which like micro dimpling are very thin and disperse around. And there are very small and very less dimpling on the surface of the acceptable sample.

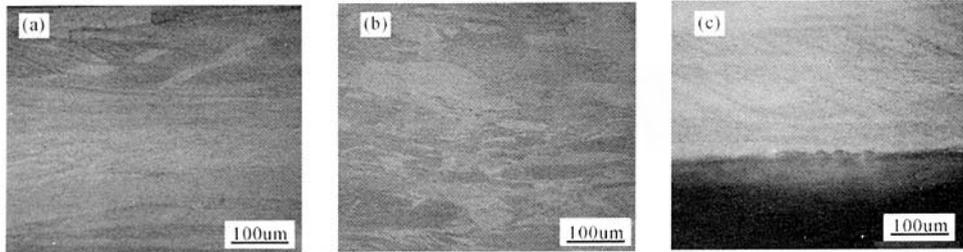
The component of the defect surface has been analyzed by energy spectrum analysis. It is not difference with the normal one. It shows that the pitting surface is not caused by the wrong component. The microstructure of the rough surface is shown in Fig. 2. It is evidence that the microstructure is working phase and there are some bigger crystal grains and it is not uniform. The grains are thinner at the boundary and are bigger in the middle. It shows that the strips are heated non-uniform or the temperature is too low to recrystallize. The structure does not recrystallize completely.

There are much minute pits at the boundary in Fig. 2 (c). The small pit may be several microns and the big pit is more than decadal microns. It is main reason that the temperature is non-uniform or the temperature is too low in the annealing furnace. When the bell cover annealing furnace is being adopted to an-

neal in batches, the anneal temperature is 600°C , the heating time is about 8 h and the holding time is about 5 h. Several strips lie in the muffle furnace along the height direction. The circular heated air is from the top to the bottom by the fan. There are convection cells which have varying-area channels between the strips. Through the channels, the protective gas enters the inner of the strips and loopback to the fan. The study on these annealing furnace shows that the strips at the bottom have the worst heating and cooling conditions. So the strips with rough surface usually emerge at the bottom^[4].

Fig. 2 Microstructure of the rough surface
(a) transverse direction; (b) longitudinal direction; (c) the boundary

The statistics about recrystallization annealing temperature shows that the best annealing temperature of nonferrous metal alloys is about 70 percent of the melting temperature^[5,6]. The recrystallization annealing temperature of KFC copper alloy is about 780°C from calculation. The temperature in practical production is lower and it is unfit. When the anneal temperature is 600°C , the strips at the top of the annealing furnace have completely recrystallized because the temperature rise rapidly and the holding time is relatively long at the top, but the strips at the bottom of the annealing furnace have partly recrystallized and easily appear the defect of rough surface because the temperature is non-uniform and the holding time is relatively short at the bottom.

To compare the component of the rough surface of KFC copper strip with one of the normal copper strip, the component abnormality has not been found. But to observe its microstructure of the rough surface, there are thinner and regular dimpling in the surface before the polishing, and bigger crystal grains are found after the polishing. The coarse structure vanished when the sample is heated higher than 700 °C. It is shown that current annealing technique is not reasonable and should be improved and optimized, such as the annealing temperature can be higher than 650 °C or the annealing time can be more than 2 h.
