# 使役环境涡轮叶片 EB-PVD 热障涂层失效机制

邓畅光,张小锋\*,邓春明,毛杰,况敏\*

DENG Canguang, ZHANG Xiaofeng, DENG Chunming, et al. Failure Mechanism of EB-PVD Thermal Barrier Coating on Turbine Blades in Service Environment[J]. Materials Research and Application, 2022, 16(1):19-28.

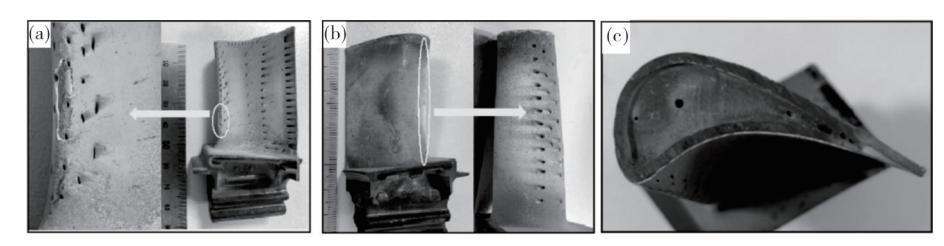
叶片为带气膜孔的空间异型构件,经正常运行 后表面整体呈砖红色,涂层剥落主要集中于进气边、 气膜孔附近区域(图1).其中叶盆表面全部呈砖红 色,靠叶尖部分颜色较靠基板部分深;叶背上存在一 个8mm×2mm的椭圆状剥落坑,剥落坑位于叶盆 叶背交界处,距叶尖约40mm,剥落坑颜色不一致, 靠叶片叶尖侧呈灰白金属色,靠叶片基板部分呈砖 红色;叶背进气面表面存在砖红、浅白色和铁灰色三 个区域,叶背进气面表面存在砖红、浅白色和铁灰色三 个区域,叶背进气边整体呈深砖红色,气膜孔出气孔 为条带状浅白色,叶背中部有两块背对背的弧形铁 灰色区域;叶尖表面整体呈砖红色加深青色,叶尖周 边露出剥离的陶瓷白色涂层.

图1叶片表面形貌图 (a)叶盆、气膜孔和脱落坑;(b)叶背和气膜孔;(c)叶尖

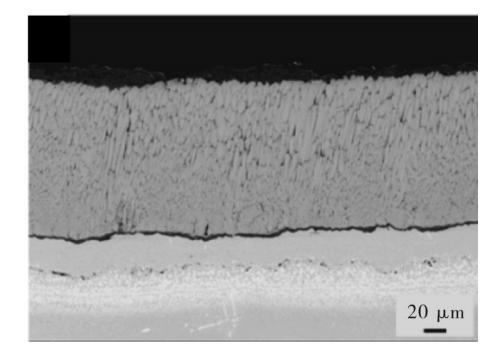
沿垂直叶片基板方向截取部分叶片,以平行于 基板面镶嵌,经研磨抛光后观察,叶片涂层表面存在 一层厚度为6~17 μm外来覆盖物,叶片涂层由覆盖 物层、EBPVD陶瓷层(柱状组织)和粘结层组成. 经能谱分析覆盖物层含Ca,Mg,Al和Si,由此可确 认,叶片表面最外层覆盖物为CMAS.涂层各层金 相组织见图2.

图2 叶片横截面金相组织图

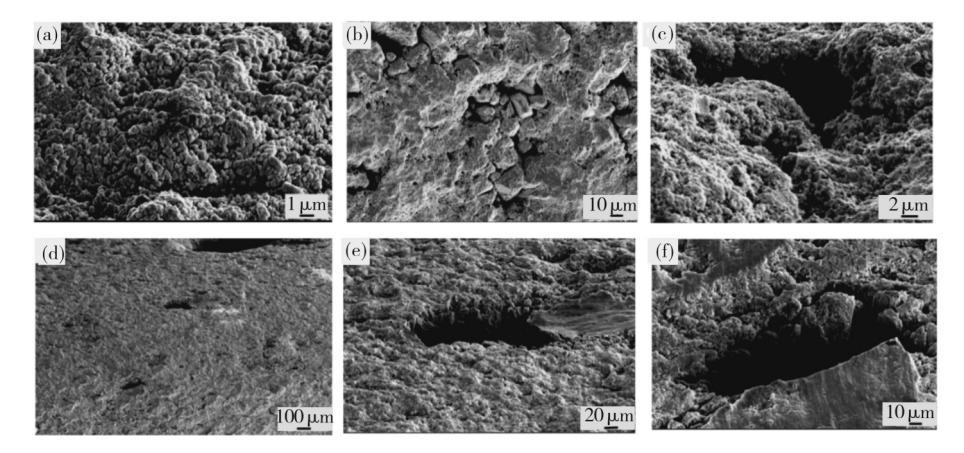
叶片进气边叶棱表面覆盖的 CMAS 层由直径 约 200~800 nm 的圆形颗粒组成,表面随机存在着疏 松、裂纹和凹坑;放大观察,疏松和裂纹为 CMAS 熔 融物点状或线状脱落后露出的稀疏的 TBCs 柱顶 端,凹坑为 TBCs 柱拔出后 CMAS 再次覆盖而显现 的凹陷;存在硬质点侧向压实疏松的 CMAS 颗粒并 留下条带状运动轨迹,所有 TBCs 柱拔出形成的独 立孔洞旁均存在机械擦痕,擦痕位于孔洞一侧或双 侧.具体形貌见图 3.

#### 图3 叶片进气边叶棱表面微观形貌图

(a)CMAS层表面形貌;(b)CMAS脱落后的形貌;(c)CMAS再次覆盖TBCs孔洞形成的凹陷;(d)CMAS表面存在的孔洞概况;(e)孔洞一侧的擦痕;(f)孔洞双侧的擦痕

此观察说明:新CMAS粘附于陈旧CMAS玻璃 上时为颗粒状,CMAS熔融物脱后露出的TBCs柱 是疏松的;叶片该部位受大量CMAS攻击前已存在 TBCs柱拔出,TBCs柱拔出或与硬质物碰撞摩擦 有关.

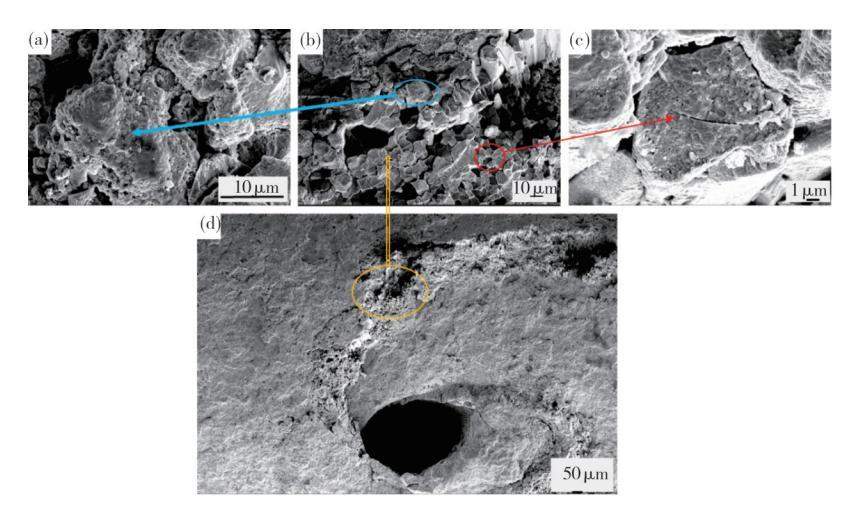
叶片进气边存在一个肉眼可见的脱落坑,是一 个约8mm×2mm的长条状凹坑,并包含4个气膜 孔(3个位于叶盆侧,1个位于叶背侧),凹坑距进气 边距叶尖约40mm;脱落坑靠基板侧为TBCs柱成 片折断区,折断区残存TBCs陶瓷柱顶端可见 CMAS覆盖,CMAS覆盖是不均匀的,远离脱落坑 处较厚,靠近脱落坑旁较薄,脱落坑由远及近是第次 减薄的;放大观察TBCs陶瓷柱顶端,新鲜断口上可 见TBCs陶瓷柱柱间裂隙.具体形貌见图4.

离脱落坑距离由远及近第次减薄的现象可知,硬质 点对脱落坑附近的撞击不止一次,叶片越靠近脱落 坑部位受硬质点撞击次数越多.因为同样气氛下 CMAS覆盖物厚度应该是一致的,TBCS柱是从底 至顶连续的柱子,顶端部分受硬质点冲击而脱落后 的残存部分将被CMAS沉积物覆盖,只有再次脱落 后露出新鲜的TBCs柱顶端又被CMAS覆盖,其厚 度才会薄于上一次.所以,从覆盖物第次减薄的现 象可以推测越靠近脱落坑位置的叶棱受外来硬质点 冲击越频繁.表明:(1)叶片脱落坑位置,是叶棱受 硬质物冲击的密集部位;(2)TBCs陶瓷柱柱间裂隙 证实,该位置(包括深度)受硬质物冲击冲击时未发 生CMAS渗透导致的TBCs本质固化.

图4 块状脱落坑四周一侧 TBCs 柱成片折断形貌图

(a)远离脱落坑的TBCs柱顶端厚的CMAS覆盖物;(b)折断TBCs柱形貌图;(c)近脱落坑处TBCs柱顶端薄的CMAS覆盖物 及柱内裂纹;(d)TBCs柱成片折断位置及分布

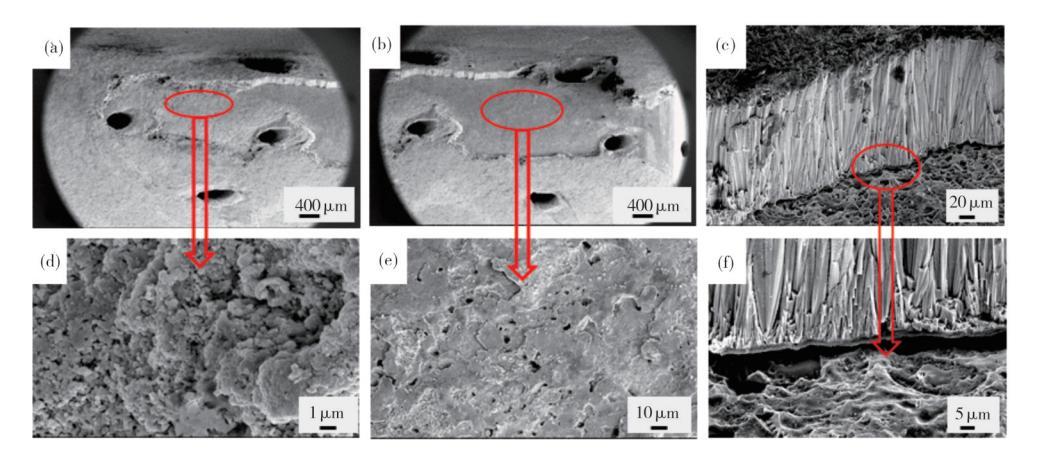
围),靠叶尖侧呈银白色,此区域包含叶盆内左二左 三与叶背气膜孔包含的范围.电镜观察,近基板侧 周围为TBCs折断区,表面由颗粒状物组成,能谱分 析含Ni,Mg,Al,Si,Ca和Cr等元素,说明该区域为 镍基高温合金基体上残存MCrAlY过渡层和陶瓷层 混合物组成.靠叶尖区域的表面呈蜂窝状,能谱分 析由 Ni和 Al组成,其基本为裸露的镍基高温合金 基体.从脱落坑侧面观察陶瓷柱可见从 MCrAlY 过 渡层根部到柱顶的完整形貌,以及可见 TBCS 柱与 基体分离线,此处叶片基体存在多处硬质点摩擦痕 迹.具体形貌见图 5.

#### 图5 脱落坑及坑内表面和侧面形貌图

(a)脱落坑表面(靠基板侧)低倍形貌图;(b)脱落坑表面(靠叶尖侧)低倍形貌图;(c)脱落坑侧面(靠叶尖侧)低倍形貌图;(d)脱落坑 表面(靠基板侧)底部高倍形貌图(残存颗粒状陶瓷层);(e)脱落坑靠叶尖侧底部高倍形貌图;(f)脱落坑侧面(靠叶尖侧)高倍形貌图

对叶棱表面的所有观察可知:(1)脱落坑为从靠 基板侧萌生,然后向叶尖侧方向扩展;(2)硬质点对 叶片进气边脱落坑旁的陶瓷柱数次撞击造成 TBCs 柱折断,并萌生了产生脱落坑的 TBCs柱与过渡层 间微裂纹;(3)块状 TBCs柱脱落后,裸露的叶片基 体仍遭受硬质点冲击;(4)叶片进气边脱落坑部位, 是受外来硬质点冲击密度最大的地方.

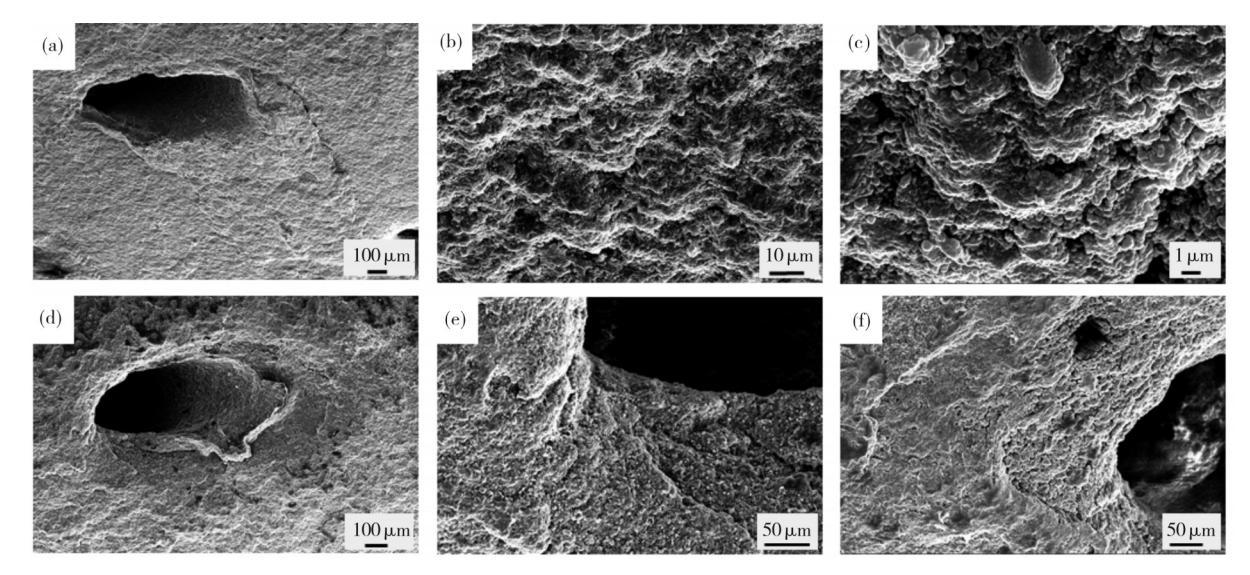
图 6 为气膜孔周围特征花纹图. 从图 6 可见,叶 盆表面 CMAS 呈波浪状分布,所有气膜孔周围均存

在围绕气膜孔的特征花纹.花纹有两种表现形式, 一是气膜孔外顺叶盆出气方向延伸的"慧尾状" CMAS 增厚花纹,二是环气膜孔四周 CMAS 脱落 纹. 第一种特征纹为半熔融态 CMAS 呈波浪状被 强力吹向顺叶盆表面气流流动方向,孔波浪状花纹 上间或可见挂于CMAS层上的大颗粒;第二种特征 纹多呈环形围绕于气膜孔左右侧,环形花纹内可见 疲劳条带,也可见CMAS脱落后露出的孔洞和 TBCS柱尖.这是由于:(1)CMAS严重攻击了叶盆 带气膜孔区域,使该区域TBCs柱尖降解为球形颗 粒:(2)叶片高温工作时,半熔融态球形颗粒呈受叶 片表面和气膜孔内气流综合作用吹向一侧形成特征 "慧尾"纹;(3)近气膜孔处CMAS渗透TBCs柱并 引起固化,固化深度由内及外呈递减趋势;(4)固化 层脱落在叶片表面留下环形花纹,固化层脱落时可 能受外界交变应力影响而留下疲劳条带.

#### 图6 气膜孔周围特征花纹图

(a)气膜孔四周增厚及顺气流方向的"慧尾"状花纹;(b)气膜孔四周增厚及顺气流方向的波浪状花纹;(c)气膜孔四周增厚层的 脱落;(d)气膜孔四周增厚层的脱落

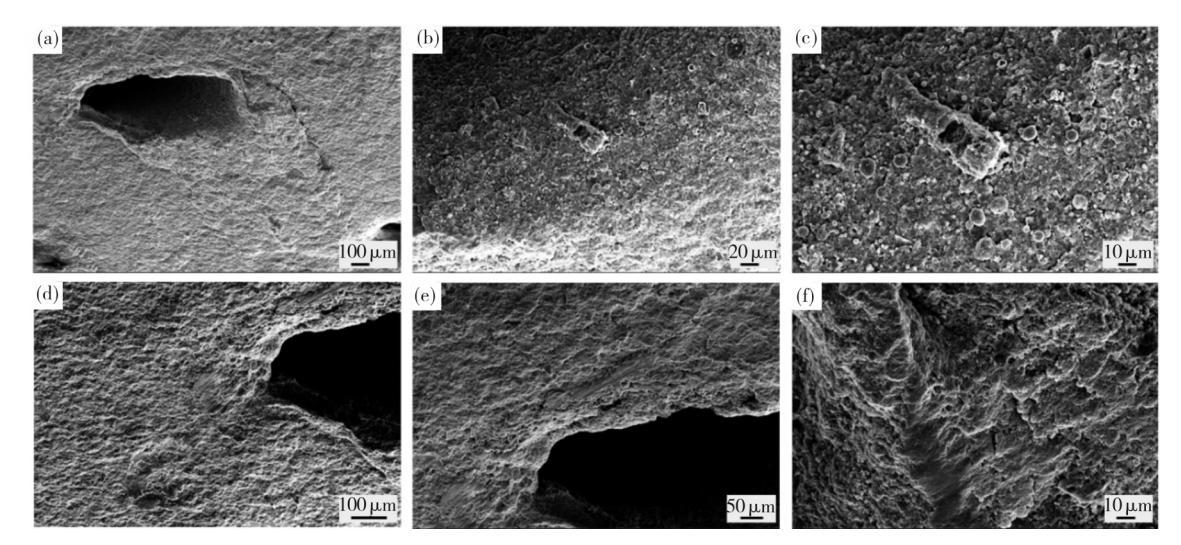
图 7 为气膜孔内存在脱落后烧损的 TBCs 柱及 该孔四周的机械擦痕.从图 7 可见:第二排气膜孔 气道内存在脱落并被烧损的 TBCs 柱, TBCs 柱旁边 散落的大颗粒均为圆形;大颗粒为细小的球形颗粒 团聚而成,该气膜孔与叶盆交界表面 CMAS 层存在 大量硬质点擦伤痕迹. 由于一般 TBCs 柱不会单 个拔出的,通常呈7个以上的集束状拔出,所以气道 内存在单个的 TBCs 柱,很大可能是一束 TBCs 柱 掠过气膜孔,部分碰撞气膜孔旁 CMAS 留下大量机 械擦痕然后飞走了,其中一个跌落气膜孔遗留下来. 以上观察说明:(1)有的气膜孔四周存在的大量 机械擦痕,很大可能是脱落的TBCs柱造成的;(2) 气膜孔内存在的TBCs柱不一定来源于气膜孔内 部,有大可能是叶盆表面飞行的TBCs柱跌落后留 驻于此.

**图7** 气膜孔内存在脱落后烧损的TBCs柱及该孔四周的机械擦痕 (a)TBCs柱在气膜孔内的位置图;(b)TBCs柱低倍形貌图;(c)TBCs柱基周围散落的圆形颗粒;(d)气膜孔左侧的机械擦痕; (e)气膜孔上侧的机械擦痕;(f)气膜孔右侧的机械擦痕

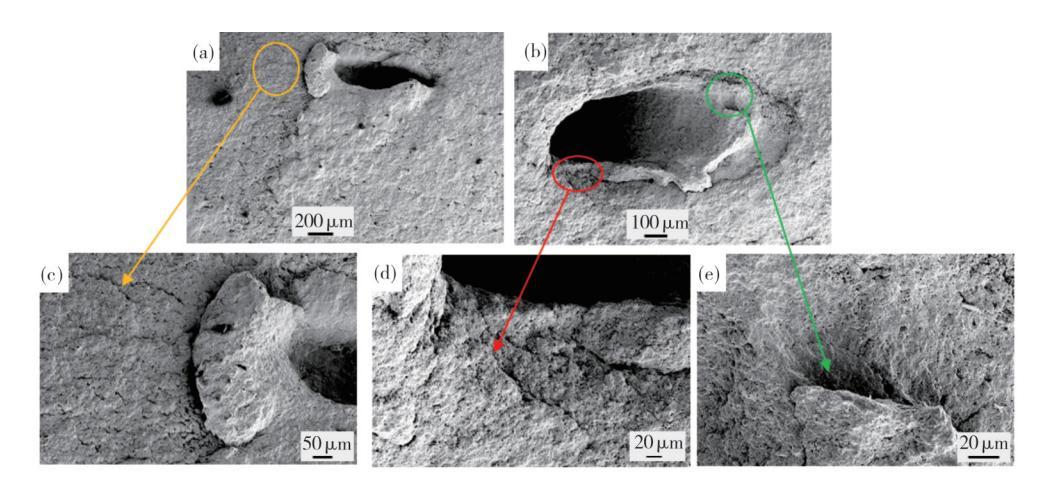
图 8 为叶背气膜孔四周 CMAS 形貌图. 从图 8 可见,叶背表面气膜孔均位于进气边附近,气膜孔四

周CMAS堆积层较厚,除顺气流方向存在"慧尾"状花纹外,第一排气膜孔四周存在条状CMAS脱落纹,有个气膜孔上近气膜孔位置存在疲劳辉纹,远离 气膜孔位置为稀疏的YSZ柱尖端.

#### 图8 叶背气膜孔四周CMAS形貌图

(a)气膜孔四周的CMAS环形堆积、慧尾状花纹堆积;(b)气膜孔四周CMAS脱落后留下的环状花纹;(c)CMAS脱落后留下的条状花纹;(d)CMAS脱落后留下的条状花纹;(e)CMAS脱落后留下的疲劳辉纹

气膜孔附近的叶片表面出现疲劳辉纹,说明: (1)此处CMAS渗透已经引起该区域本质上固化, 应变容限丧失,导热率降低,这是因为TBCS的形态 和结构,使CMAS可以通过毛细作用被吸入所有开 放的孔中,如果渗入层较厚,当温度降低时,CMAS 冷却并凝固,导致渗透区域形成高模量的本质上固 化<sup>[11]</sup>;(2)较厚的高模量本质固化区域内部微裂纹 在受外界交变应力作用发生扩展,留下疲劳辉纹,而 叶片服役中的外界交变应力就是其速度改变的机械 应力和高低温循环的热应力,故疲劳辉纹由机械应 力或热循环应力导致;(3)气膜孔周围有的位置 CMAS固化不完全彻底,留下稀疏的疲劳条带;(4) 远离气膜孔位置TBCs内部虽有CAMS渗透但没 有发生本质性上固化,CMAS剥离时仅去除了固化 的自身,留下了TBCs尖端;(5)气膜孔周围CMAS 脱落呈环状剥落,也证实CMAS固化程度由气膜孔 四周向外是递减的.

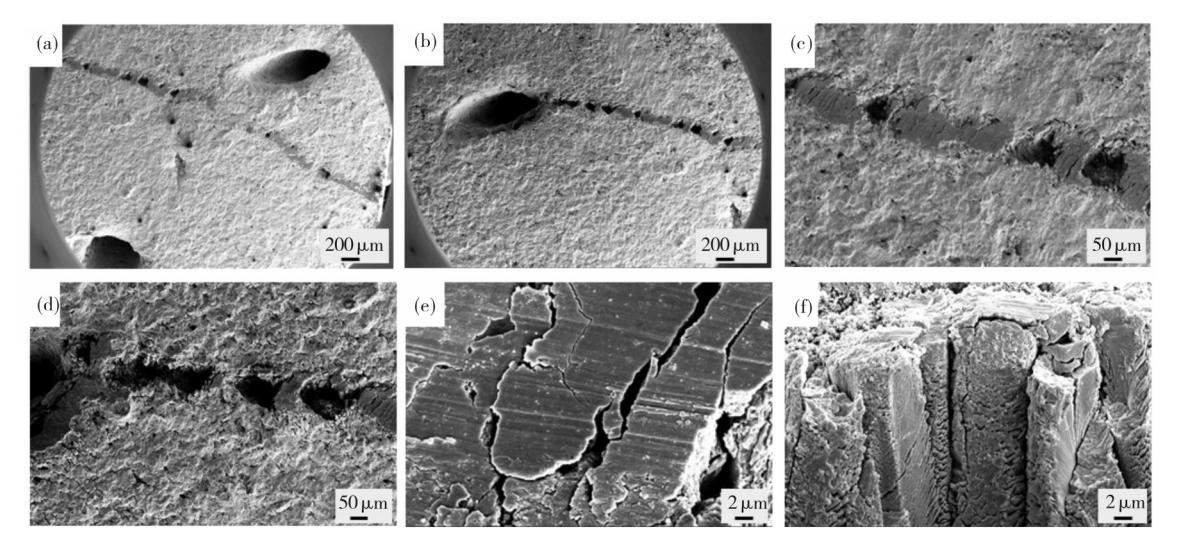
图 9 为叶背进气边表面气膜孔周围硬物碾压摩 擦形貌图.从图 9 可见:第二、三排气膜孔间存在一 条较长的终止于第二排气膜孔的大块硬物碾压摩擦 轨道,轨道长约 2.8 mm、宽约 100 μm,硬物运动轨 道上可见硬物碾压摩擦痕和 TBCs柱断续状成束拔 出的孔洞、垂直于运动轨道的裂缝,其中近终止处的 拔出孔洞较多,远离终止处的碾压摩擦痕较多;碾压 摩擦痕为数硬质点同时摩擦留下的犁沟,从拔出孔 洞往 TBCS柱内观察可看到,暴露的 TBCS 柱表面 呈颗粒状和穿晶断裂状,柱上横、纵向裂纹止于柱 内,未越过晶界向旁柱扩展,柱侧表面再次覆盖了薄 层CMAS熔融物.

#### 图9 叶背进气边表面气膜孔周围硬物碾压摩擦形貌图

(a)碾压摩擦轨道宏观形貌图;(b)碾压摩擦轨道终止于第二排一气膜孔;(c)碾压摩擦轨道近起始处;(d)碾压摩擦轨道近终止 处;(e)轨道上的裂纹和犁沟;(f)孔洞内YSZ柱表面的球状颗粒、柱上裂纹、穿晶断裂表面和薄的CMAS覆盖层

以上观察可知:(1)碾压摩擦轨道只有一条,说明是一大块硬质物同时所为,由轨道宽度大致可以 推测硬质物有100µm左右;(2)硬质物碾压摩擦 CMAS表面留下数条平行状犁沟,可以推测硬质物 由数颗粒组成;(3)由孔洞观察到的TBCs侧面颗粒 状,说明TBCs柱拔出前已受CMAS攻击;(4)穿晶 裂纹说明发生了TBCs柱发生了柱内断裂;(5)横向 裂纹未贯穿至旁柱,可以知道残留区域未发生 CMAS本质固化;(6)洞侧再次覆盖CMAS薄层说 明TBCs柱拔出后再次受到CMAS攻击.

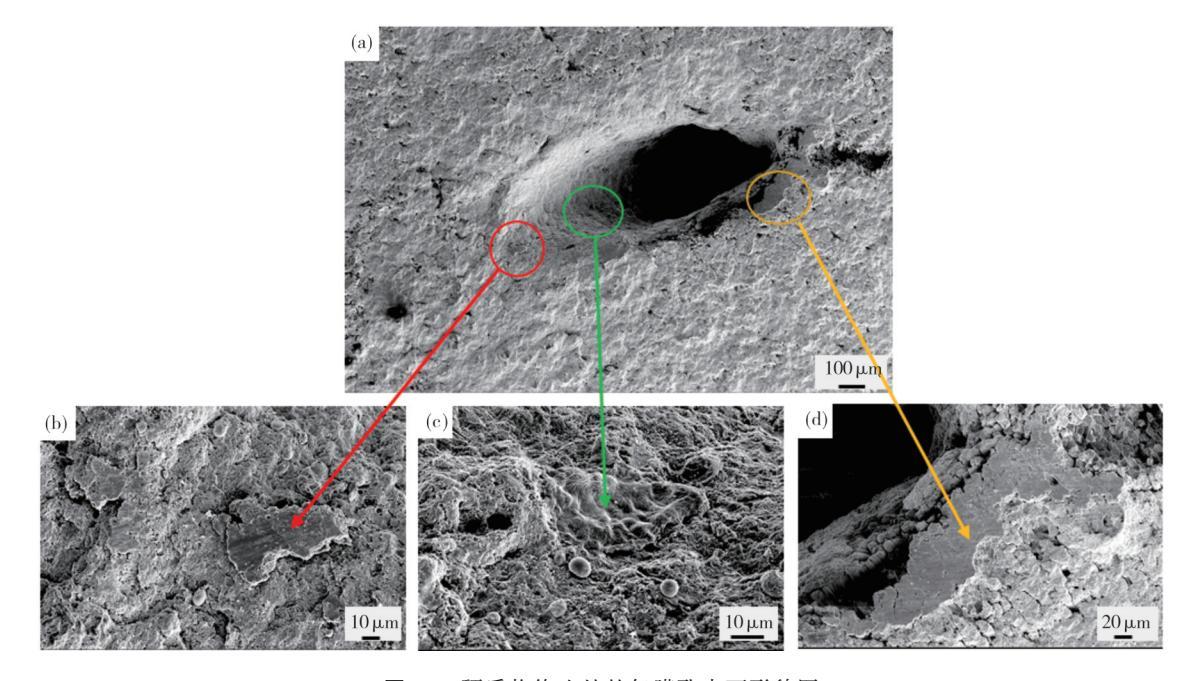
图 10 为硬质物终止处的气膜孔表面形貌图. 从图 10 可见,硬质物摩擦轨道终止处的气膜孔周围,叶片与气膜孔交界区域约 1/4 受硬质物碾压,其 余部分几乎全部脱落,露出TBCs柱顶端.该气膜 孔内发现数块CMAS脱落块,最大的两块中,靠近 孔内侧的表面稍光滑,呈半熔融态,旁边还有数颗圆 形熔融物;靠近孔外侧的表面可见犁沟.

以上观察说明:(1)气膜孔周围 TBCs 已受

CMAS攻击,但未发生本质性固化;(2)气膜孔周边 CMAS层脱落与硬质点碰撞有关;(3)碰撞碾压叶 片表面 CMAS层的硬质物可能是脱落的结晶 CMAS块;(4)气道内残留硬质状 CMAS脱落物可 能非同时留驻.

图 10 硬质物终止处的气膜孔表面形貌图

(a)气膜孔四周的表面形貌;(b)气膜孔外侧的脱落CMAS;(c)气膜孔外侧的脱落CMAS;(d)气膜孔被碾压区域
